# JOINT TRANSPORTATION RESEARCH PROGRAM

## Assessment of Bridges Subjected to Vehicular Collision

Wang, Y., & Thrall, A. P. (2019). *Assessment of bridges subjected to vehicular collision* (Joint Transportation Research Program Publication No. FHWA/IN/JTRP-2019/01). West Lafayette, IN: Purdue University. <https://doi.org/10.5703/1288284316870>

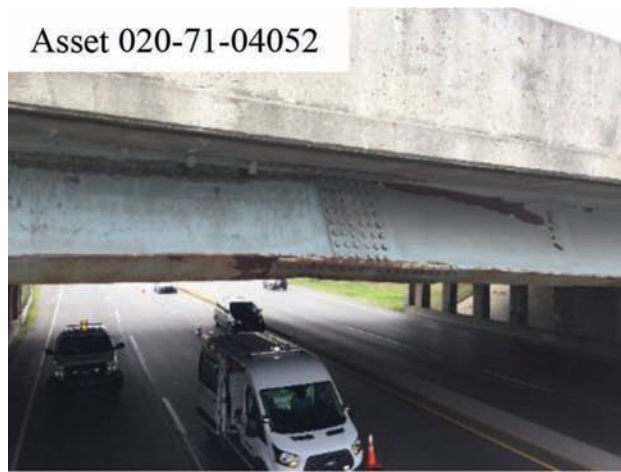
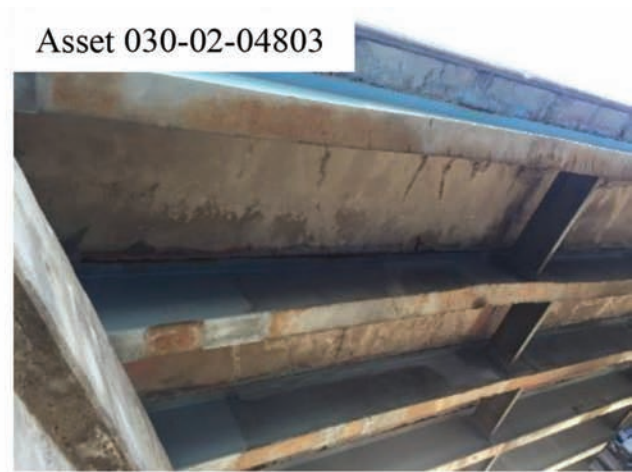
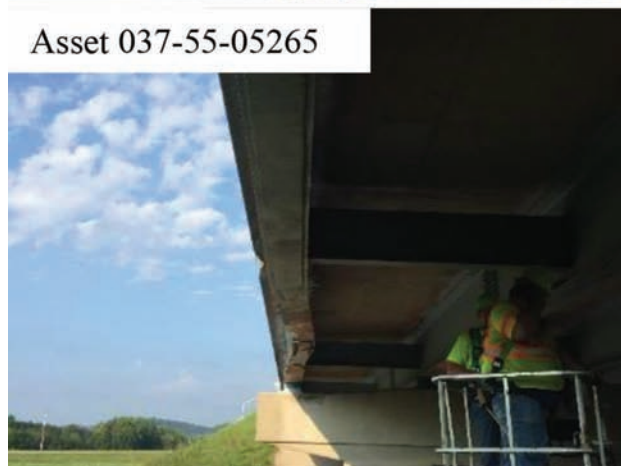
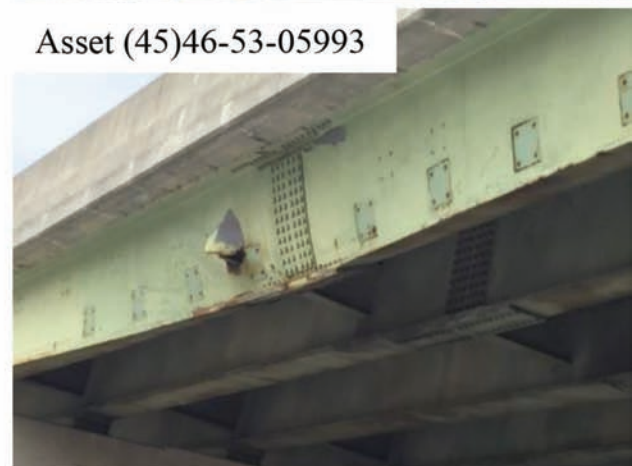
**Figure 1.2** Damage to steel girders in the four bridges tested in this project.

Field monitoring was performed by measuring strains in each bridge under quasi-static truckloads (i.e., two heavily loaded dump trucks). Four bridges with Category T damage were monitored (Figure 1.2). The research proposal planned to monitor six. However, there were few vehicular collisions during the project and there were challenges in obtaining lane closures to monitor damaged bridges due to high traffic volumes. The plan to monitor four bridges was agreed upon by the Business Owner and Principal Investigator. The focus was on monitoring the behavior of exterior damaged girders, symmetric undamaged girders, and adjacent girders. Surface strains were measured using a 3D DIC system consisting of two cameras ( $2448 \times 2050$  pixels, 0.472 in. lenses) mounted on a rigid bar (Figure 2.1). Strains were calculated using ARAMIS (2017), with a gauge length of 2.97 in. Specifically, twenty frames were taken within 15 seconds of one another for each load case (i.e., the trucks stayed in place when photographs were taken). Time averaging was implemented using the temporal binomial filter in ARAMIS (2017), averaging data over 10 frames for each load case. The spatial median filter in ARAMIS (2017) was used to reduce outlying data points. Area averaging was also performed, including data across the entire pattern but excluding the 0.5 in. development length of the tape along all edges. Full-field strain maps included in this report feature only temporal and spatial filtering.

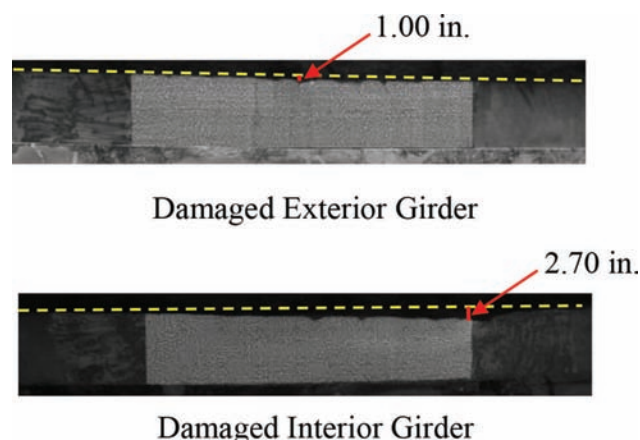
**Figure 4.12** Displacement at the peak point of the damage of Asset 030-02-04803.

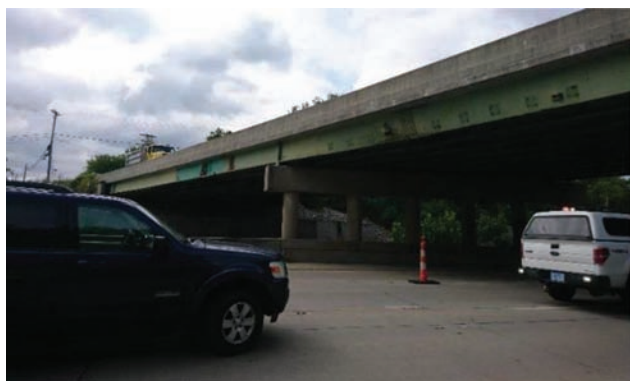
**Figure 4.21** Damaged girder of Asset (45)46-53-05993.

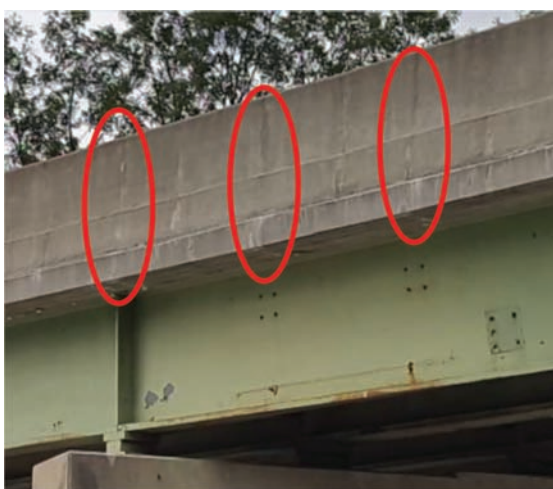
Cracks in Negative Moment Region

Figure 4.24 Cracks in the bridge and FE model.

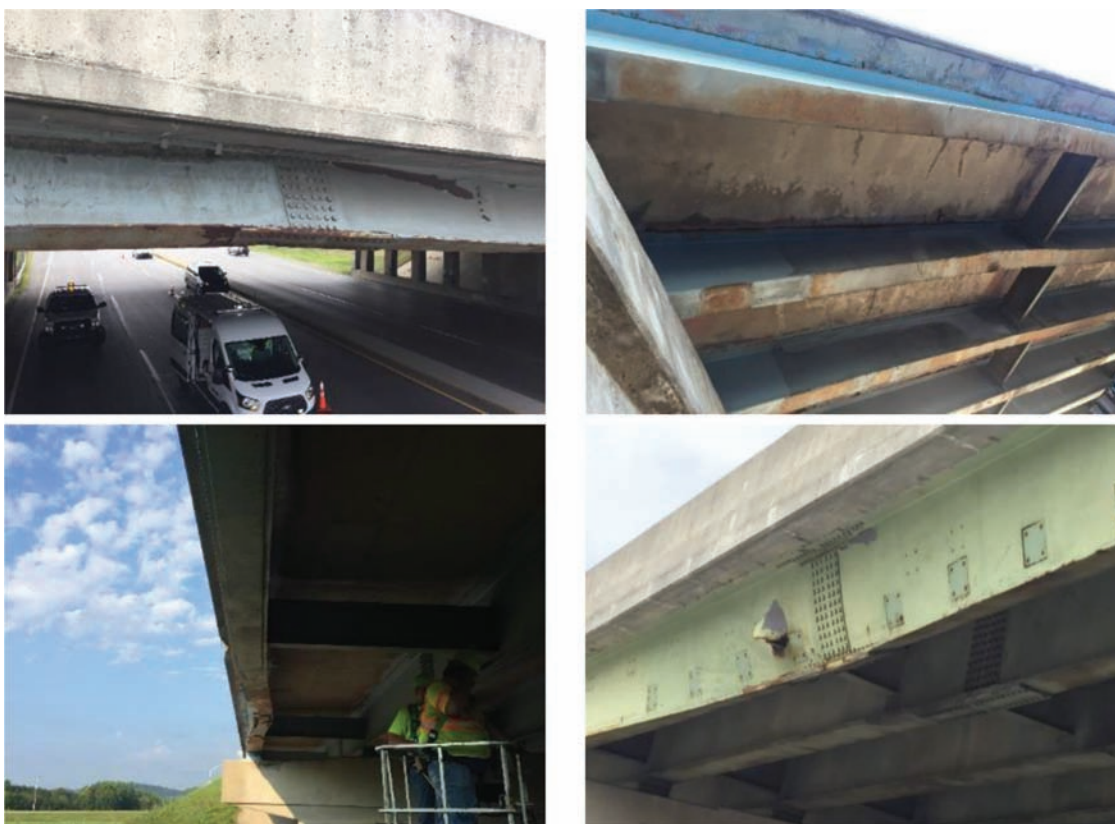
Figure A.1 Examples of damage.
